Hacking everything, by Chris Evans / scarybeasts

## Reverse engineering a forgotten 1970s Intel dual core beast: 8271, a new ISA

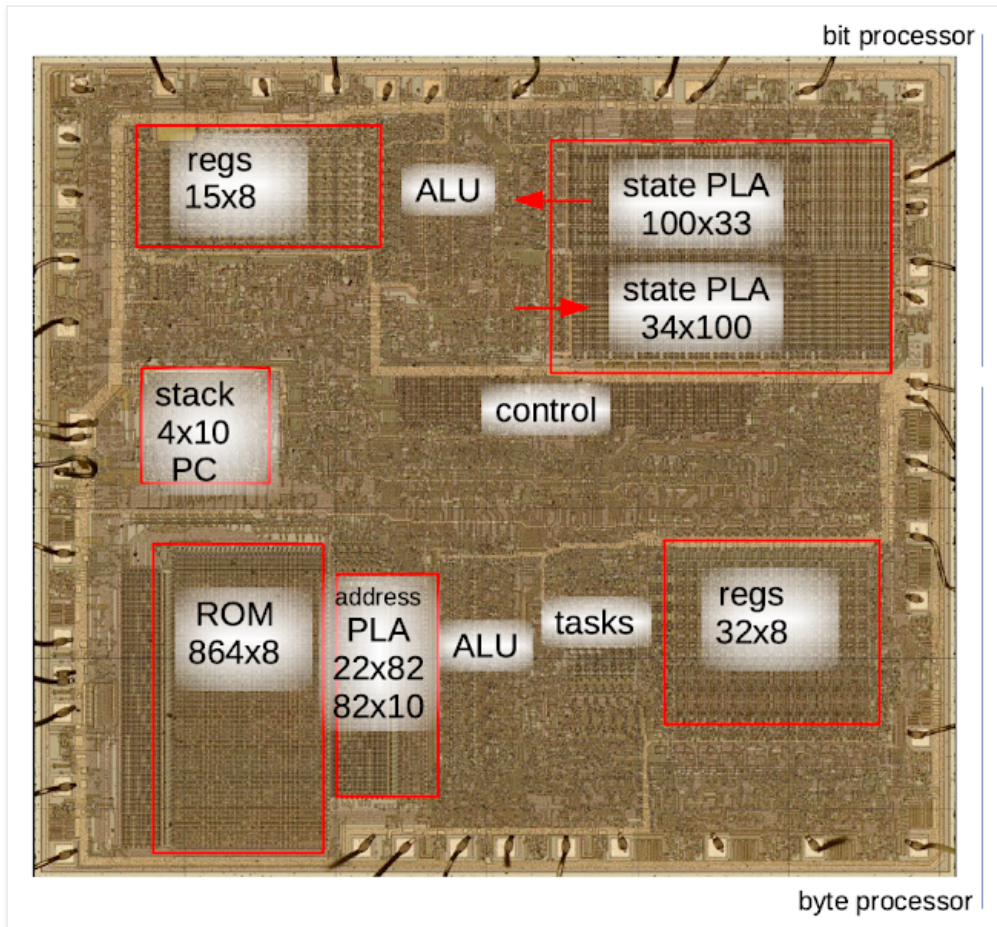
Finally, here's a diagram (courtesy of Ken). It's an early estimation of how the architecture we've seen in the documents so far might map to the silicon. As a dual processor behemoth, note how there's two ALUs, two sets of registers, lots of PLAs (including a couple to the left and right of the "control" label), and plenty of patches of silicon with unknown function.

The breakthrough was catalyzed when the hardware investigations got a good read on the wiring and content of one of the instruction PLAs associated with the byte processor. The PLA in question is actually the darker rectangular block to the left of the "control" label in the image above. It is populated like this:

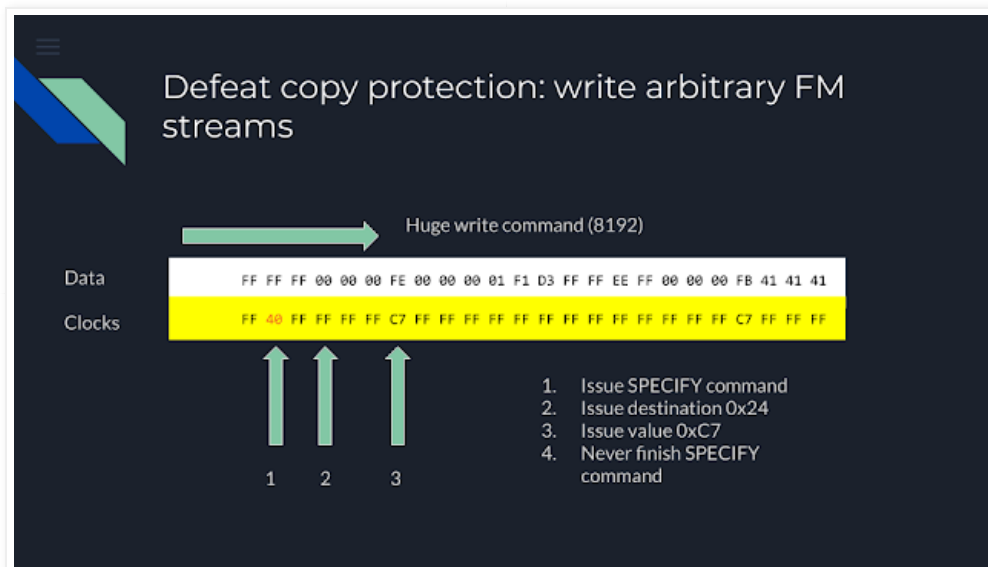
So, while the WRITE DATA command is running, we're going to sneak in some parallel SPECIFY commands to "corrupt" registers for the running WRITE DATA command, without disturbing it. Specifically, we're only going to corrupt the clocks byte register (MMIO R36) at the precise times necessary to write clocks byte values other than 0xFF. The overall operation looks like this:
